Attachment L - Chester Area Maintenance Yard

VDOT MS4 (General Permit No. VAR04)
Chester Area Headquarters Facility
VDOT District No. 4

Facility Name: Chester Area Headquarters Facility
Location: 2201 West Hundred Road, Chester, VA, 23831
Latitude: N 37.351882* **Longitude** W 77.4062*

Date of Visit: October 23, 2012
Entry Time: 8:38a.m. (approx)
Exit Time: 10:20 a.m. (approx)

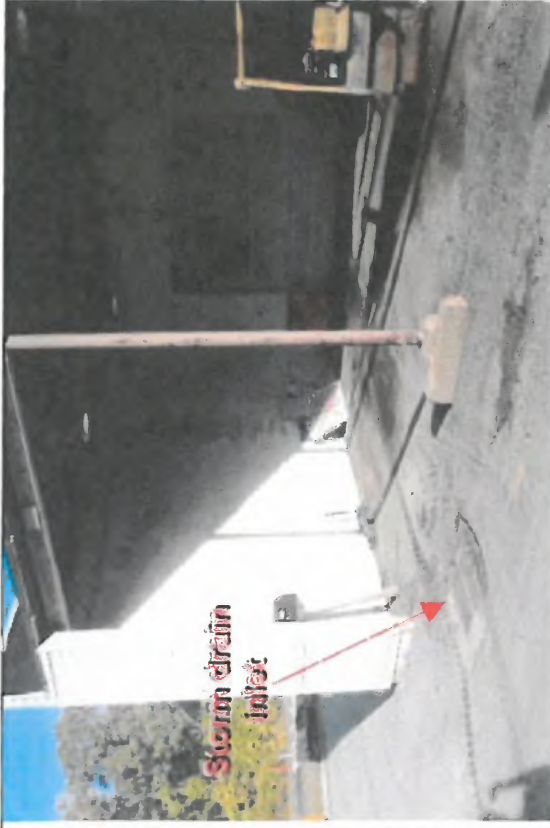
3. A storm drain drop inlet was located near the southwest corner of the storage shed (see Photograph 1). BMPs for the storm drain inlet were not evident. Vehicle tracking of what appeared to be a petroleum product was observed overtop and adjacent to the inlet (see Photographs 2 and 3). The VDOT Area Maintenance Superintendent explained that a "bobcat" machine likely drove from the covered vehicle storage area where there was staining on the ground surface and past the storm drain inlet. Based on discussions with VDOT staff, stormwater runoff which enters into this storm drain inlet is discharged to the roadside drainage ditch on the west side of the onramp to I-95 South, described above in the Facility description and pictured in Photograph 4. A visible sheen was observed on the water surface near the outfall to the I-95 South, drainage ditch (see Photograph 5). The EPA Inspection Team and VDOT staff swirled a stick through the sheen and noted that the material broke apart rather than congealing back together, indicating that the sheen was likely caused by organic material rather than petroleum products. Water samples were not collected and analyzed to confirm whether there was a presence of petroleum products in the standing water.

Photograph 1 – View of storm drain inlet near the southwest corner of the storage shed.

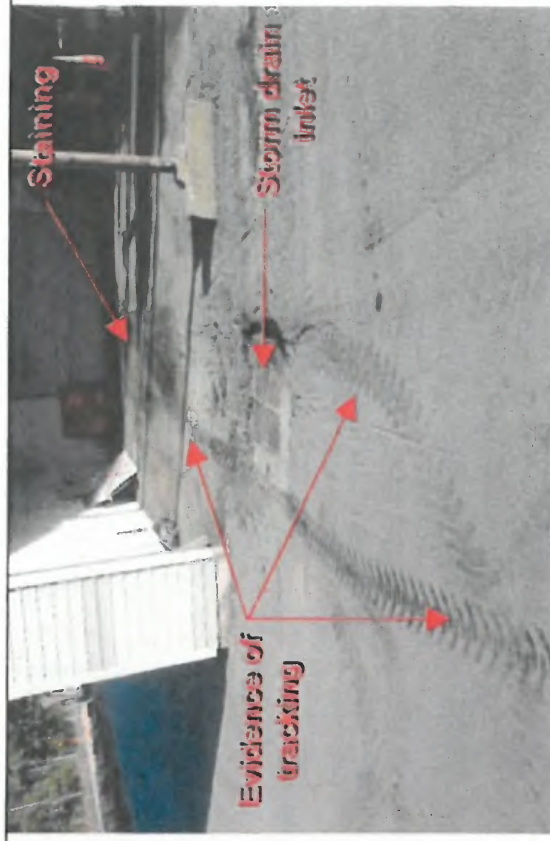
Photograph 2 – Additional view of storm drain inlet shown in Photo 1. Note evidence of tracking and lack of inlet protection.

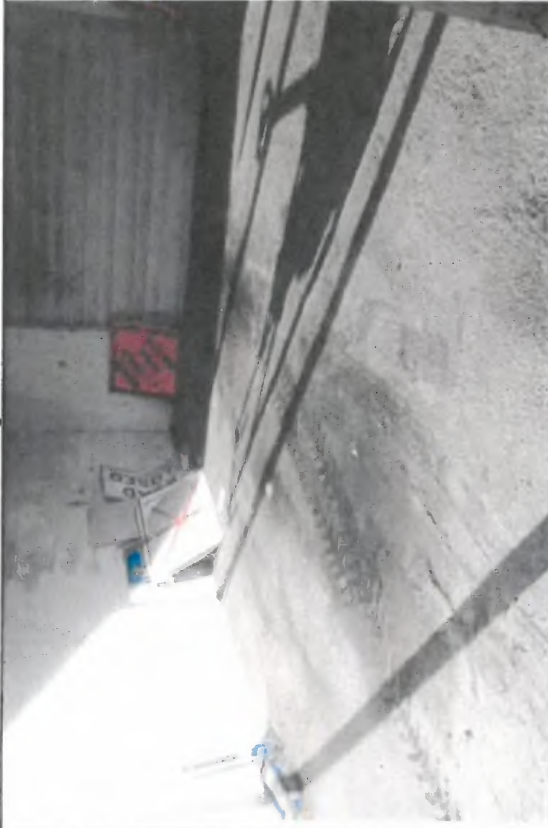
Photograph 3 – Closer view of staining on ground surface in covered storage shed shown in Photos 1 and 2.

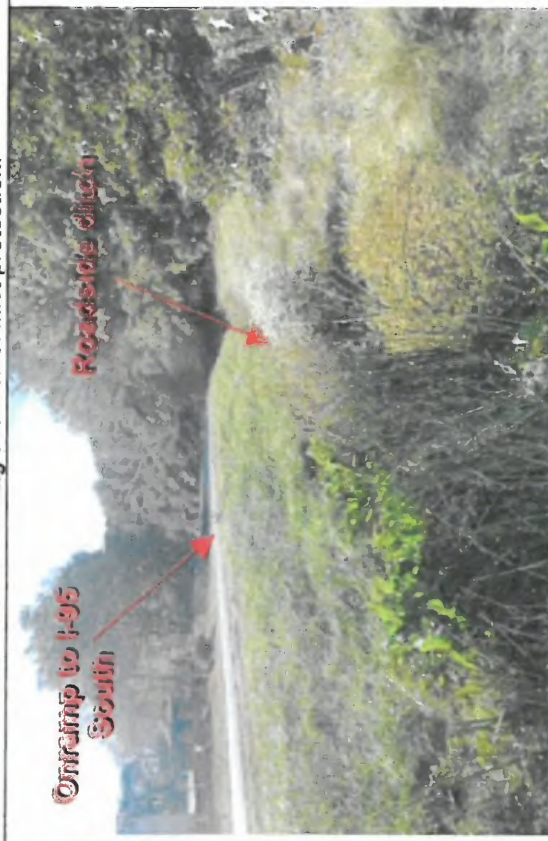
Photograph 4 – View of roadside ditch along onramp to I-95 South to the west of the Facility.

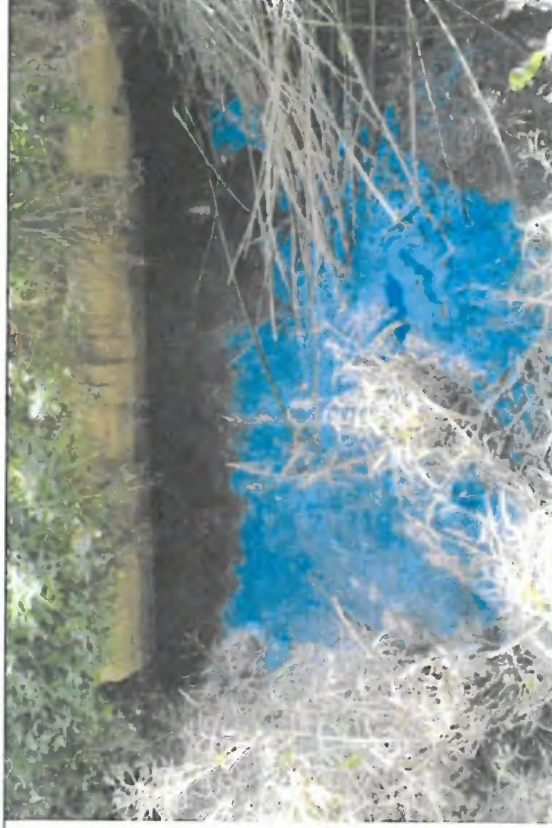
Photograph 5 – View of standing water adjacent to outfall from the Facility to the roadside ditch shown in Photo 4.

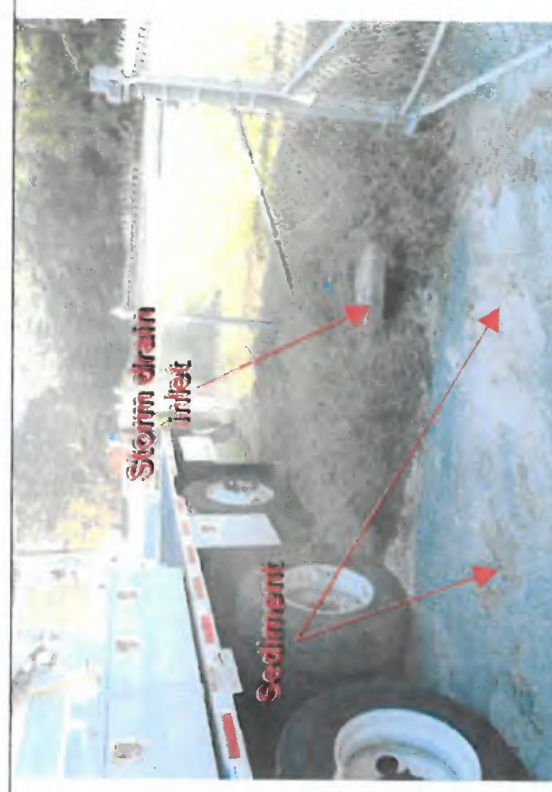
4. Sediment was observed on the impervious ground surface upgradient and adjacent to the storm drain inlet near the western entrance gate to the Facility (see Photograph 6). Inlet protection was not provided for the inlet (see Photograph 7). Based on discussions with VDOT staff, stormwater runoff which enters into this storm drain inlet is discharged to the roadside drainage ditch on the west side of the onramp to I-95 South, described above in the Facility description and pictured in Photograph 4.

Photograph 6 – View of storm drain inlet near western entrance gate to the Facility. Note sediment on impervious surface near inlet.

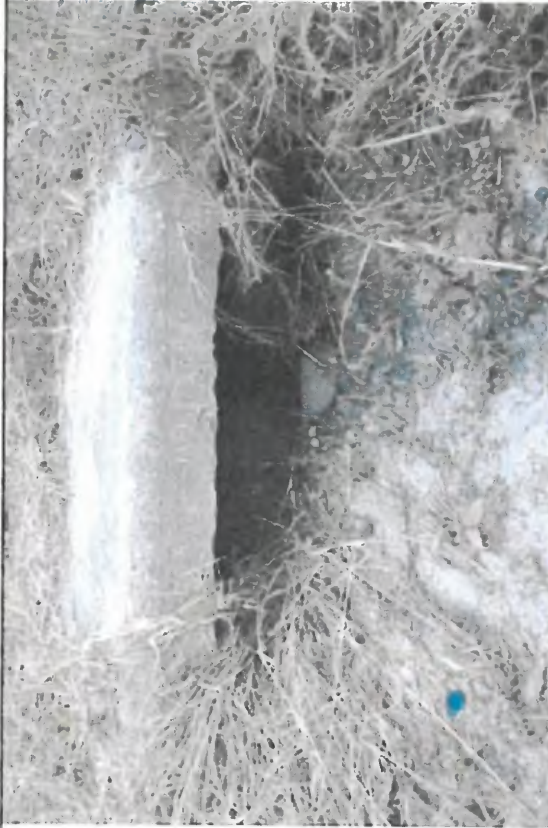
Photograph 7 – Close-up view of storm drain inlet shown in Photo 6.

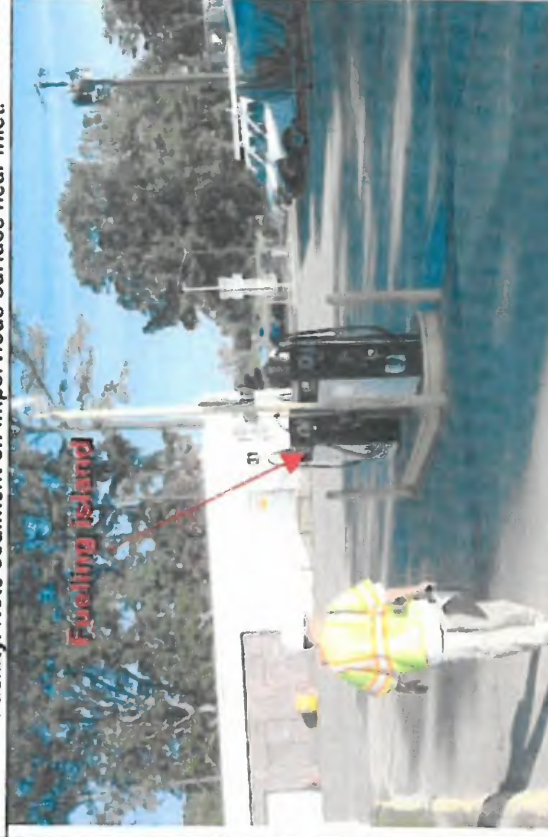
5. An uncovered fueling island was located directly to the east of the storage building near the center of the Facility (see Photograph 8). The VDOT Area Maintenance Superintendent explained that all State vehicles may fuel at this location, not just VDOT vehicles. A storm drain drop inlet was located about 50 feet to the north/northeast of the fueling island (see Photograph 9). BMPs for the storm drain inlet were not evident and a visible sheen was observed on the surface of standing water within the inlet (see Photograph 10). Based on discussions with VDOT staff, stormwater runoff from the surface area around the fueling island which enters into this storm drain inlet is discharged to the roadside drainage ditch on the west side of the onramp to I-95 South, described above in the Facility description and pictured in Photograph 4.

Photograph 8 – View of uncovered fueling island directly to the east of the storage building near the center of the Facility.

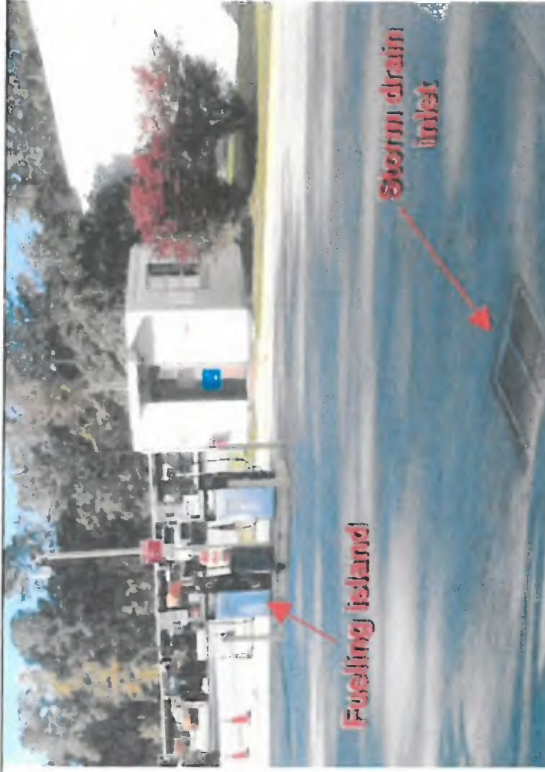
Photograph 9 – View to south of fueling island. Note storm drain inlet without BMPs for inlet protection.

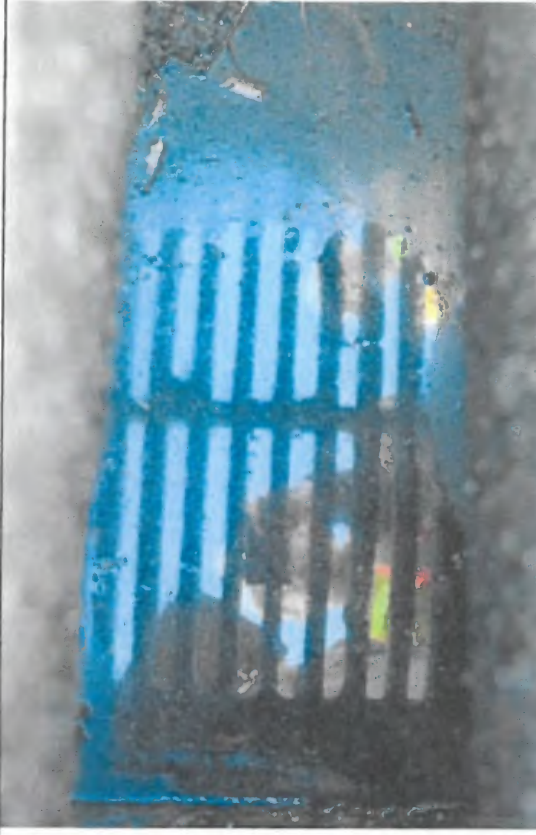
Photograph 10 -- View into storm drain inlet shown in Photo 9. Note visible sheen on surface of water.

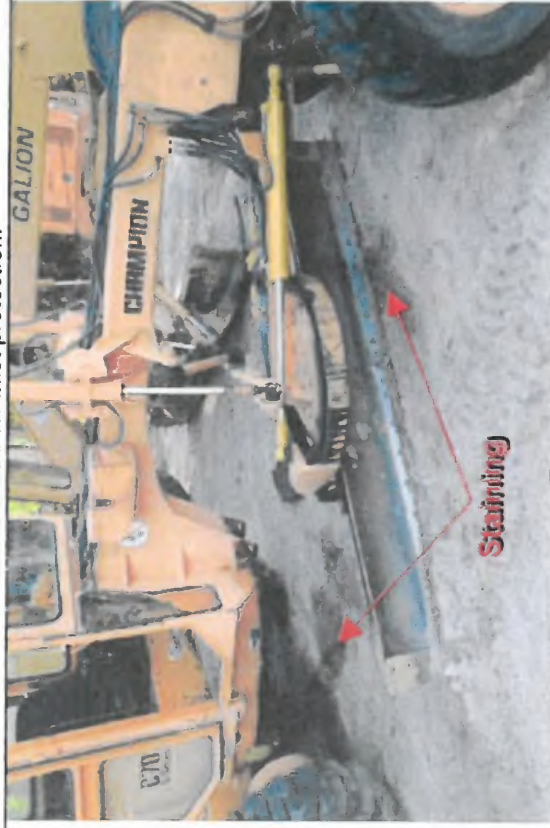
6. Staining was observed on the ground surface beneath a "motor grader" parked along the eastern perimeter of the Facility (see Photograph 11). The motor grader was directly upgradient of a flow pathway which led to a location where stormwater runoff would exit the Facility via overland flow along the eastern perimeter of the Facility (see Photographs 12 and 13).

Photograph 11 – View of staining on ground surface beneath motor grader.

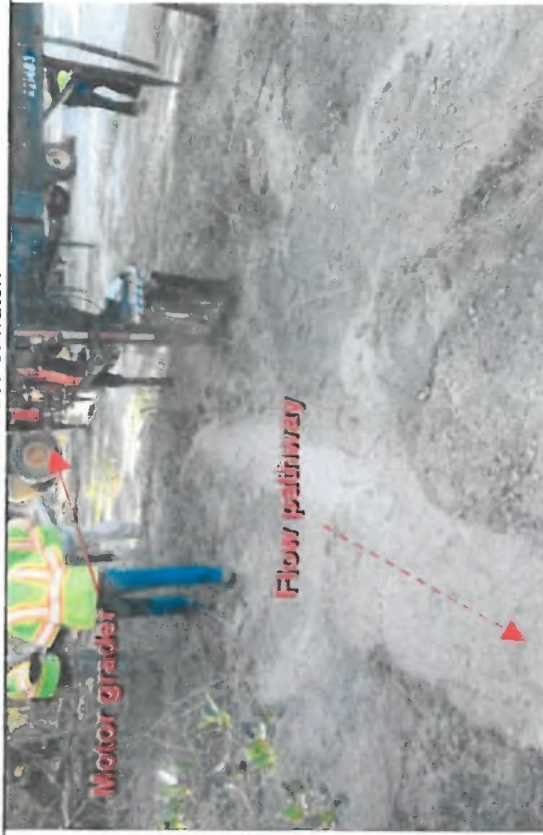
Photograph 12 – View of flow pathway downgradient of motor grader shown in Photo 11.

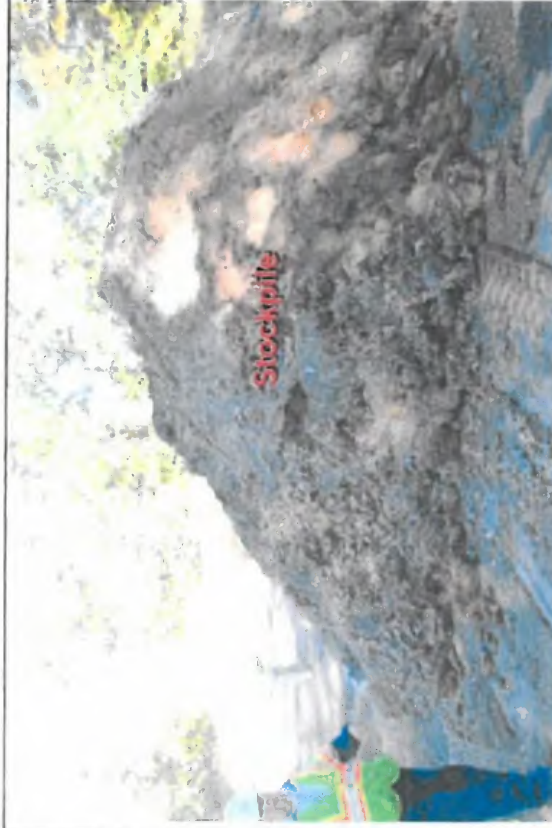
9. A remote stockpile area was located about one quarter mile north of the Facility, to the west of I-95 (see Photographs 17 and 18). The VDOT Area Maintenance Superintendent explained that the main stockpile at the site was composed primarily of dirt, rock, gravel, and leaves which had been removed from VDOT's roadside ditches and from VDOT roadways by street sweeping (see Photograph 1). The VDOT Area Maintenance Superintendent stated that VDOT uses a contractor for street sweeping. The type of street sweeper the VDOT contractor uses was not discussed during the inspection.

Photograph 17 – View of main stockpile at remote stockpile area.

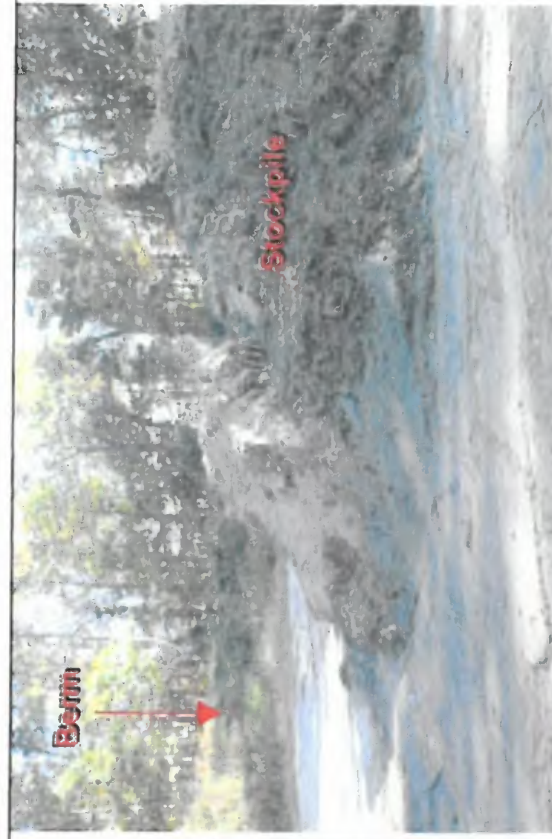
Photograph 18 – View of another portion of the stockpile shown in Photo 17.

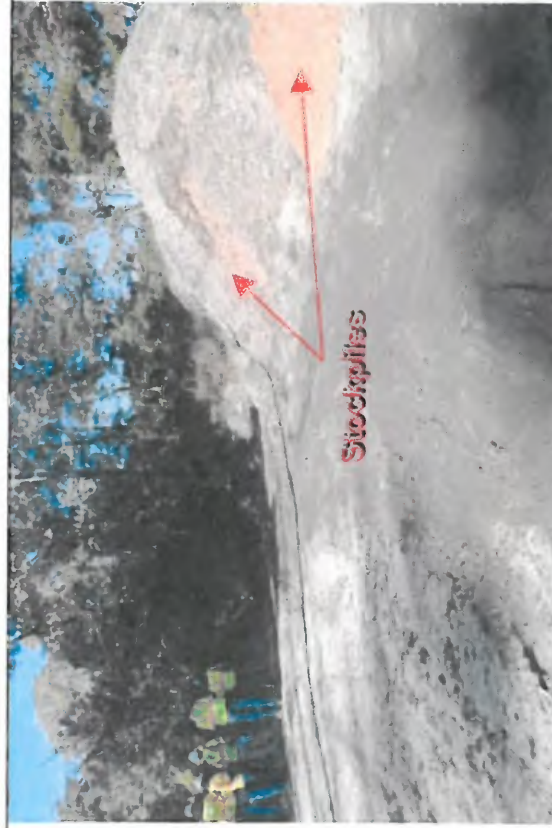
Photograph 19 – View of additional stockpiles at remote stockpile area.

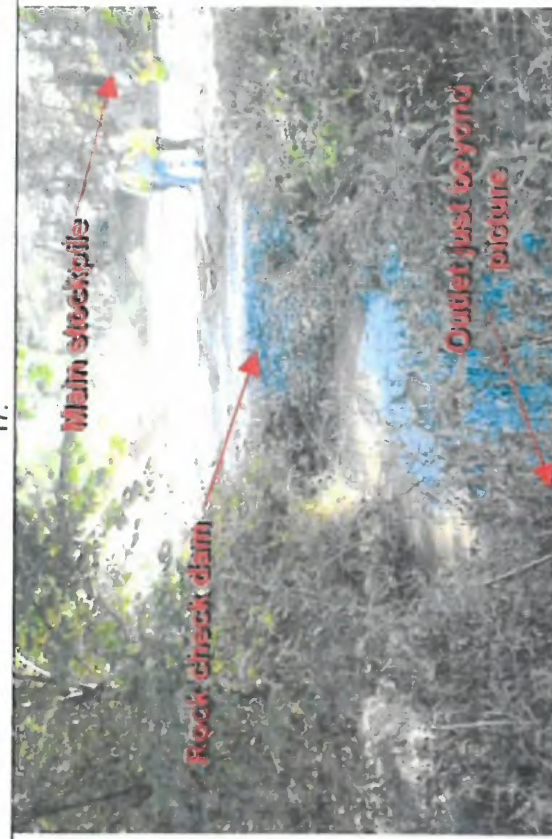
10. VDOT staff explained that there was a large berm around the entire remote stockpile area (see Photograph 18) and that stormwater runoff from the area discharged beyond the berm through an outlet pipe along the western side of the stockpile area to a roadside ditch along the onramp to I-95 South (see Photographs 20 through 23). Accumulated sediment and debris was observed adjacent to a rock check dam installed upgradient of the outlet pipe from the stockpile area (see Photographs 24 and 25).

Photograph 20 – View showing main stockpile and approximate location of outlet through the large berm.

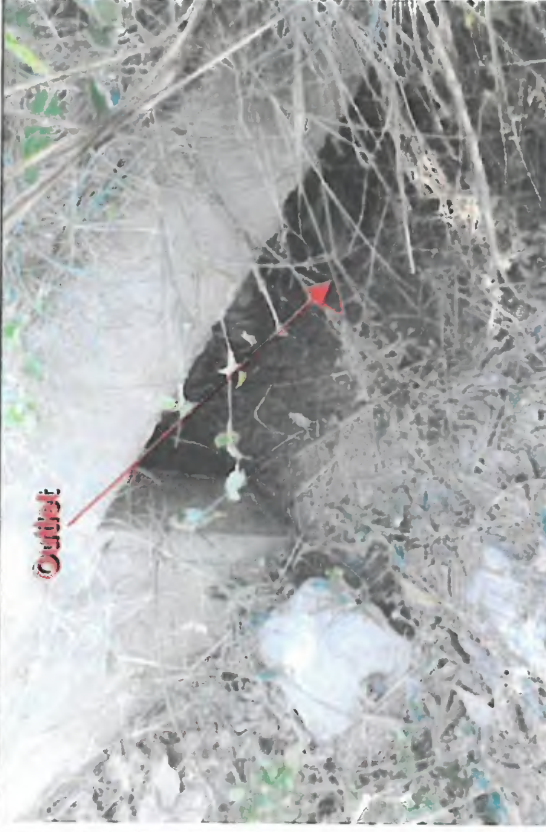
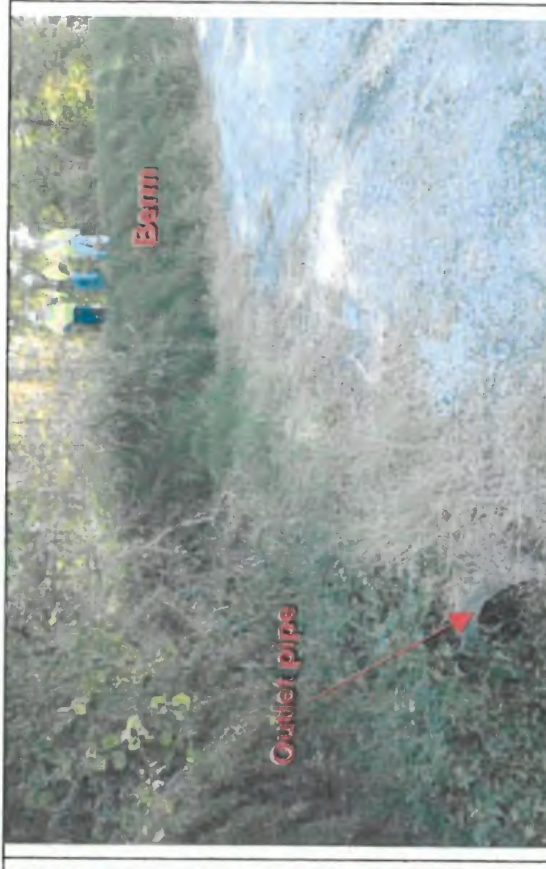
<p>Photograph 21 – View of outlet noted in Photo 20.</p> <p>Photograph 22 – View of downgradient end of outlet pipe from stockpile area shown in Photos 20 and 21.</p>

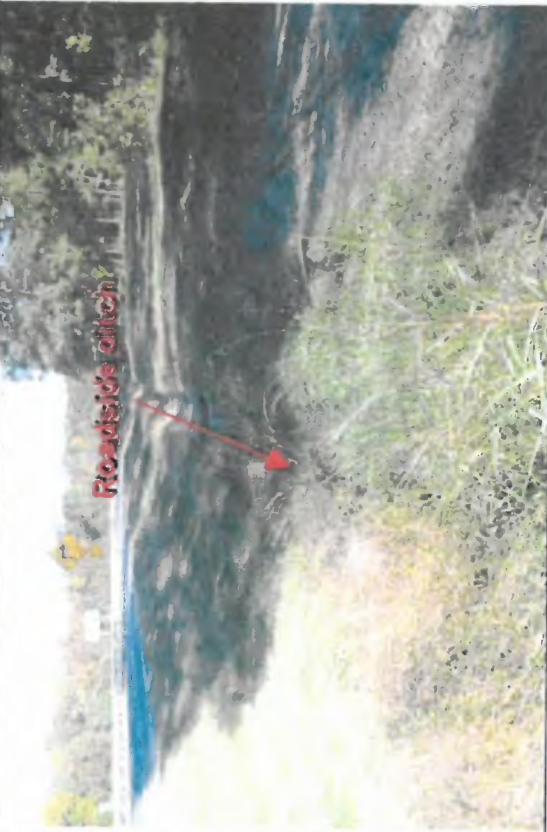
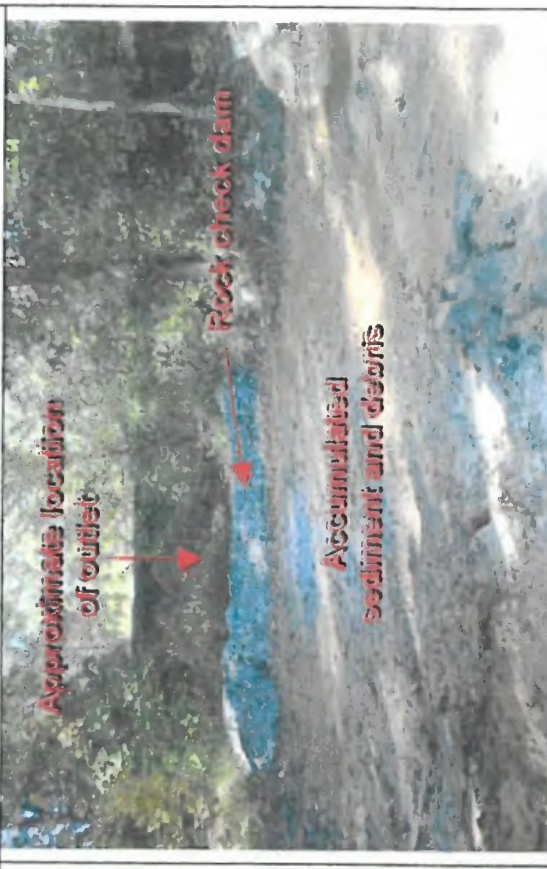
<p>Photograph 23 – View of roadside ditch along the onramp to I-95 South, downgradient of outlet pipe shown in Photo 22.</p> <p>Photograph 24 – View from main stockpile toward outlet shown in Photos 20 and 21. Note accumulated sediment and debris upgradient of rock check</p>
